# NEW MDS DELETE KIT FOR GM 5.3L L82, L83 & L8B ENGINES

**MDK400**

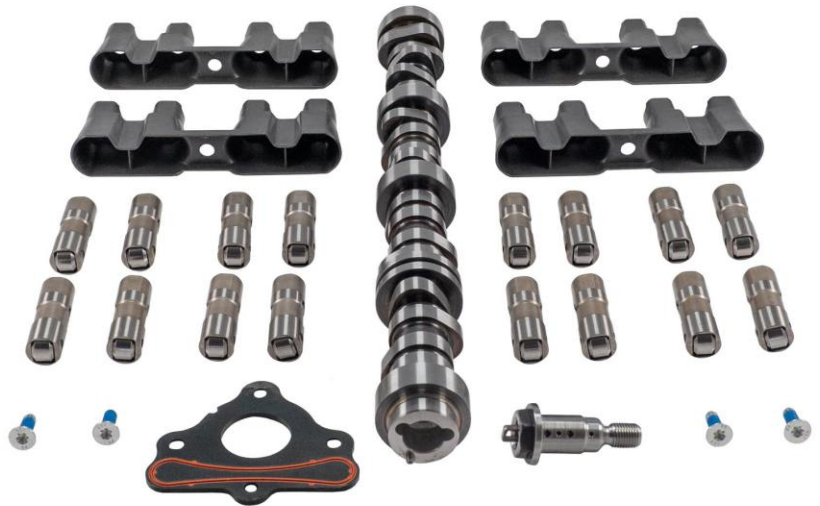
Component #	Description	Qty
MC1429	Camshaft	1 Camshaft
JB-2079	Valve Lifter	16 Lifters
MLG100	Lifter Guide	4 Guides
MF127	Thrust Plate	1 Thrust Plate
VCTO-1001	VVT Oil Control Valve	1 Valve

- When installing a delete cam, the Active Fuel Management lifters must be replaced using Non-Active Fuel Management lifters.
- The valve lifter guides used in Non-Active Fuel Management engines are different from those used in Active Fuel Management Engines and must be replaced when installing the Non-Active Fuel Management lifters
- The VLOM Must Be Replaced With A Non-Active Fuel Management Valley Cover.
- Pushrod length must be checked during installation to verify that the correct length pushrods are being used
- The vehicle engine control module/Power train control module must be reprogrammed to turn off the Active Fuel Management System in the operating software
